Manhole Inspection Summary

Manhole # S45K2_019MH

Insp Date: **1/9/08 1:22 PM**

Location Address: **1435 Cherry St**

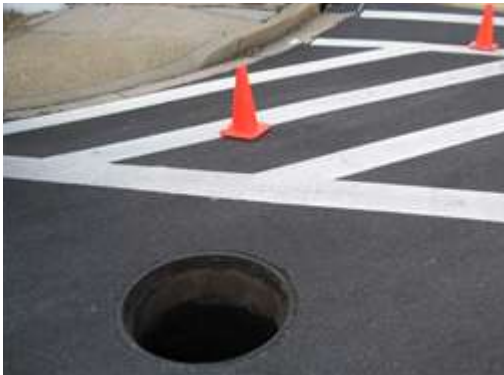
Location View

Fairhaven & Cherry St

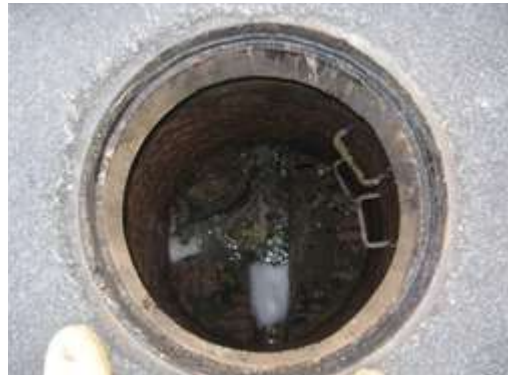
Top View

steps

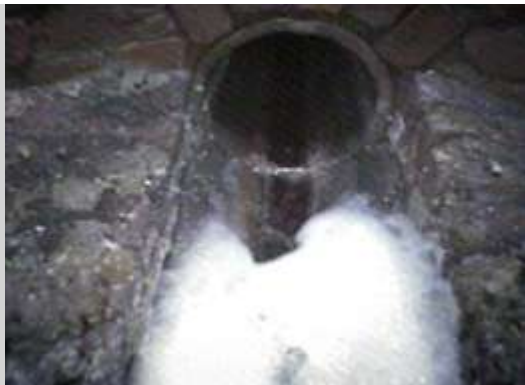
6 O'Clock Inflow

8 in. Circular Gravity Sewer
Pipe In @ 6 O'Clock

Pipe Height: **8.4** (in.) Rod and Bar (Angled)
Pipe Material: **Clay** ☐ Pipe Lined
Invert Depth: **7.89** (ft.) Flow Characteristics: **Slow**
Deposits: ☒ **None** ☐ Mud ☐ Sludge ☐ Debris ☐ Grease
Silt Depth: (in.) Deposits Extent:
Infiltration: **None** Pipe Seal Cond: **Sound**

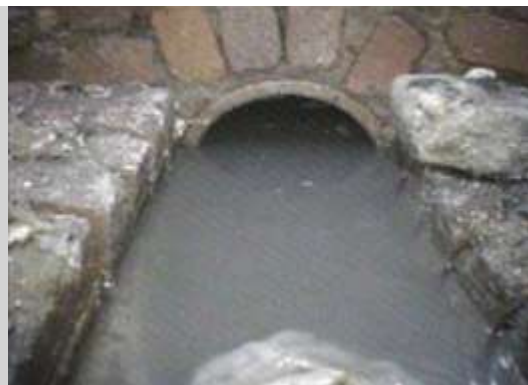
9 O'Clock Inflow

8 in. Circular Gravity Sewer

Pipe In @ 9 O'Clock

Pipe Height: **8.4** (in.) Rod and Bar (Angled)

Pipe Material: **Clay** ☐ Pipe Lined

Infiltration: **None** Pipe Seal Cond: **Sound**
